Stereo 120 Tag 13

Much more conventional...

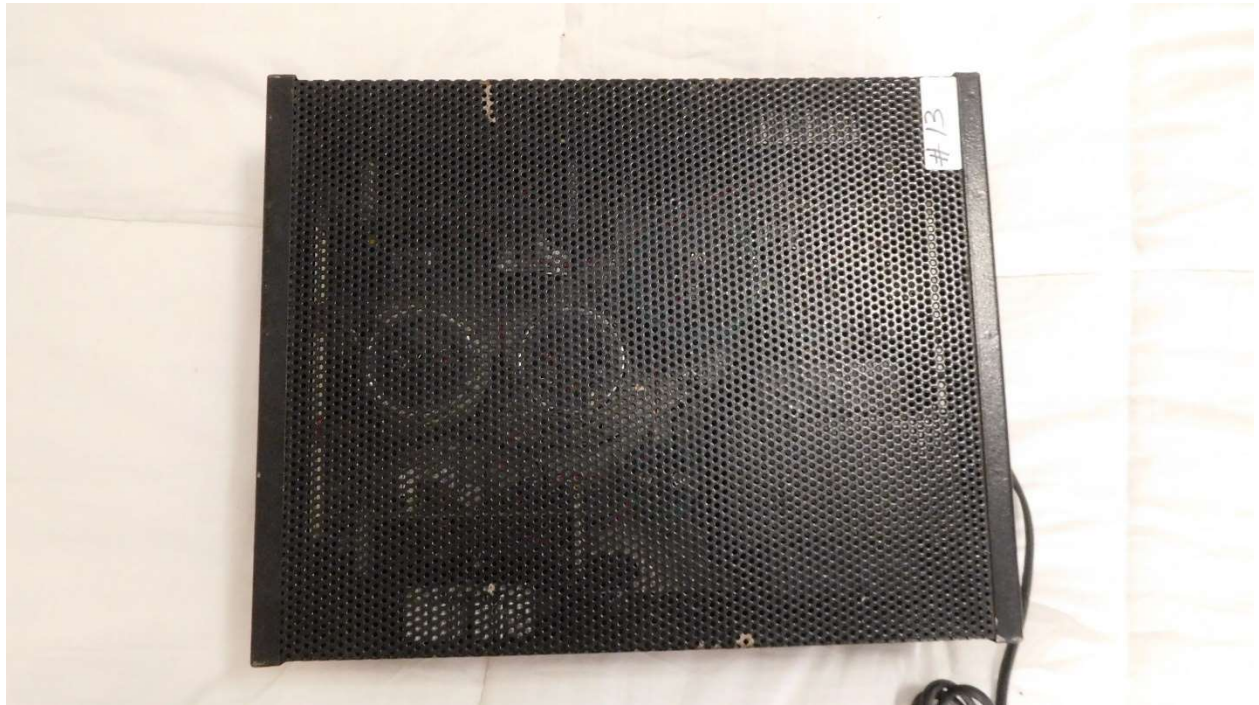
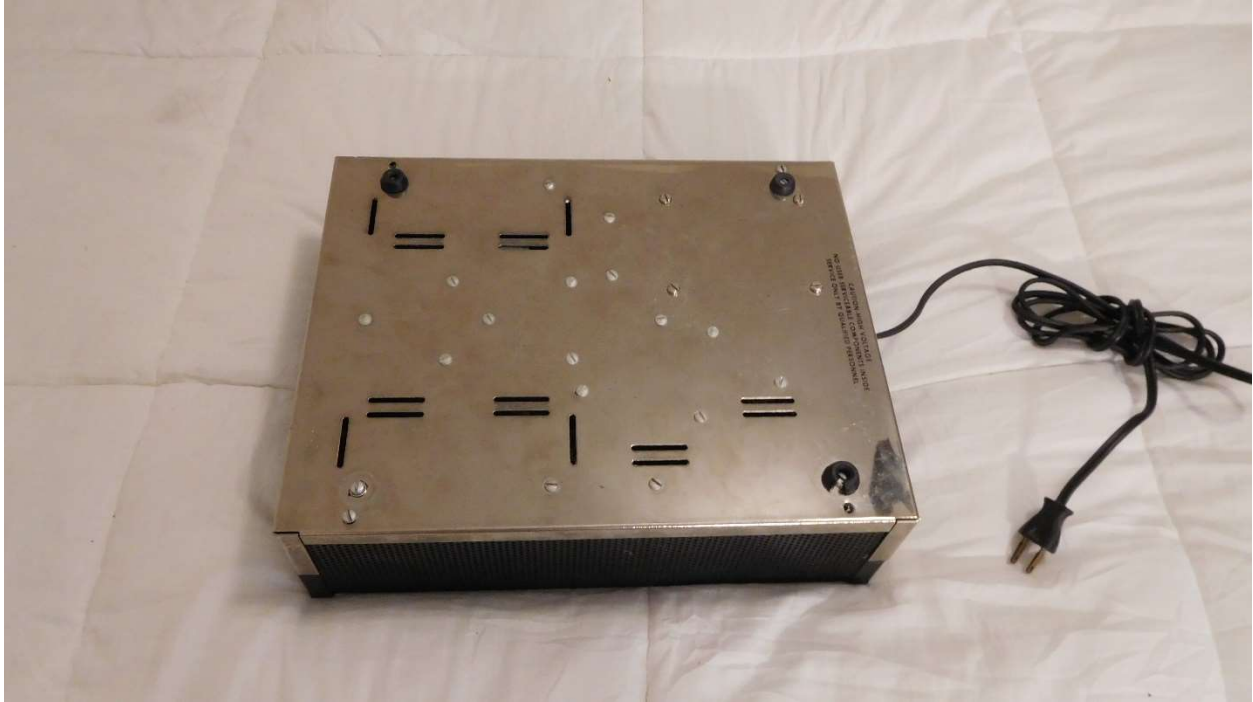
A bit of auxiliary heatsinks were added, but otherwise the unit is fairly stock. We have disconnected the transformer output because in its current form, the unit typically blows a fuse if the transformer output is connected to the power supply. Disconnected Transformer output voltage measures good. That's really all you need to know to apply the Upgrade Kit to this unit.

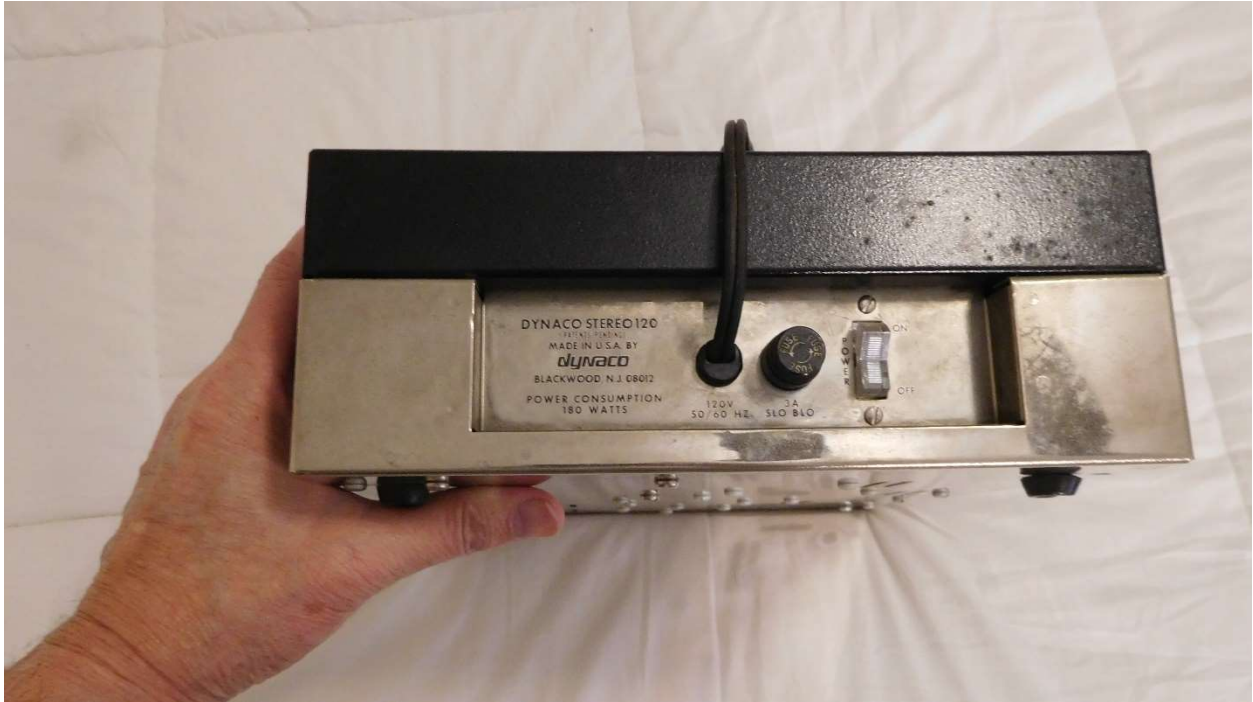
Needs new feet.

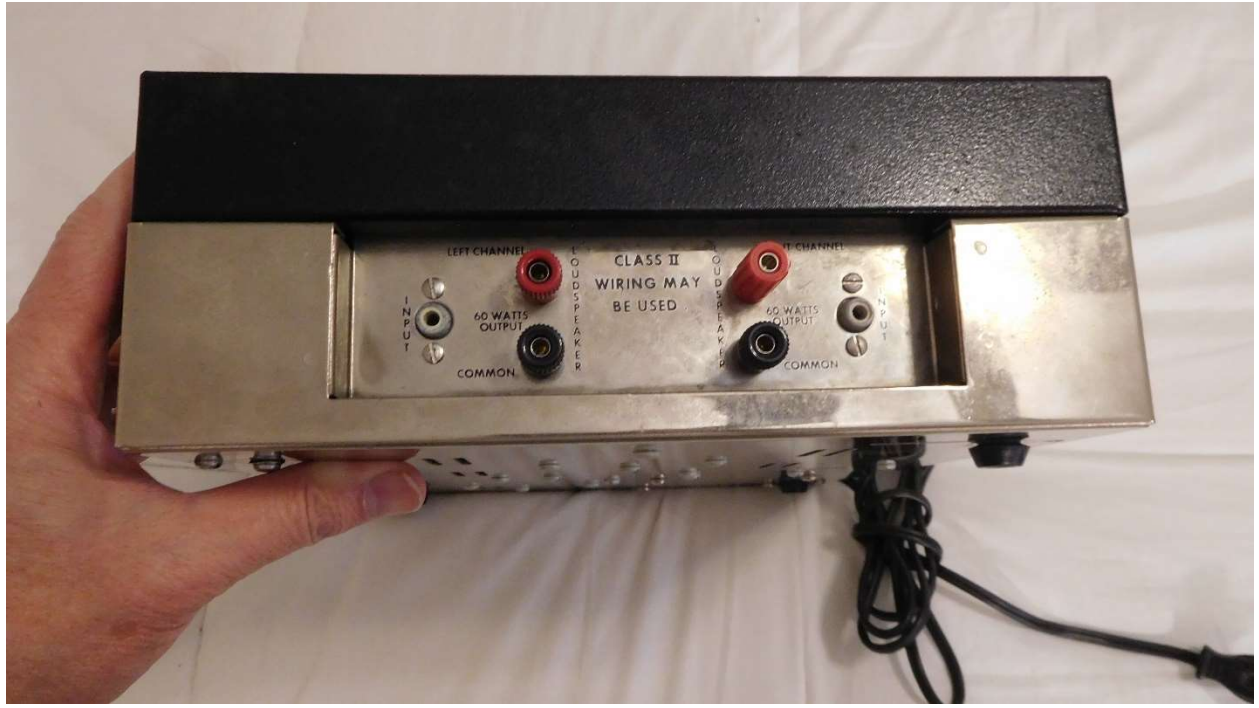
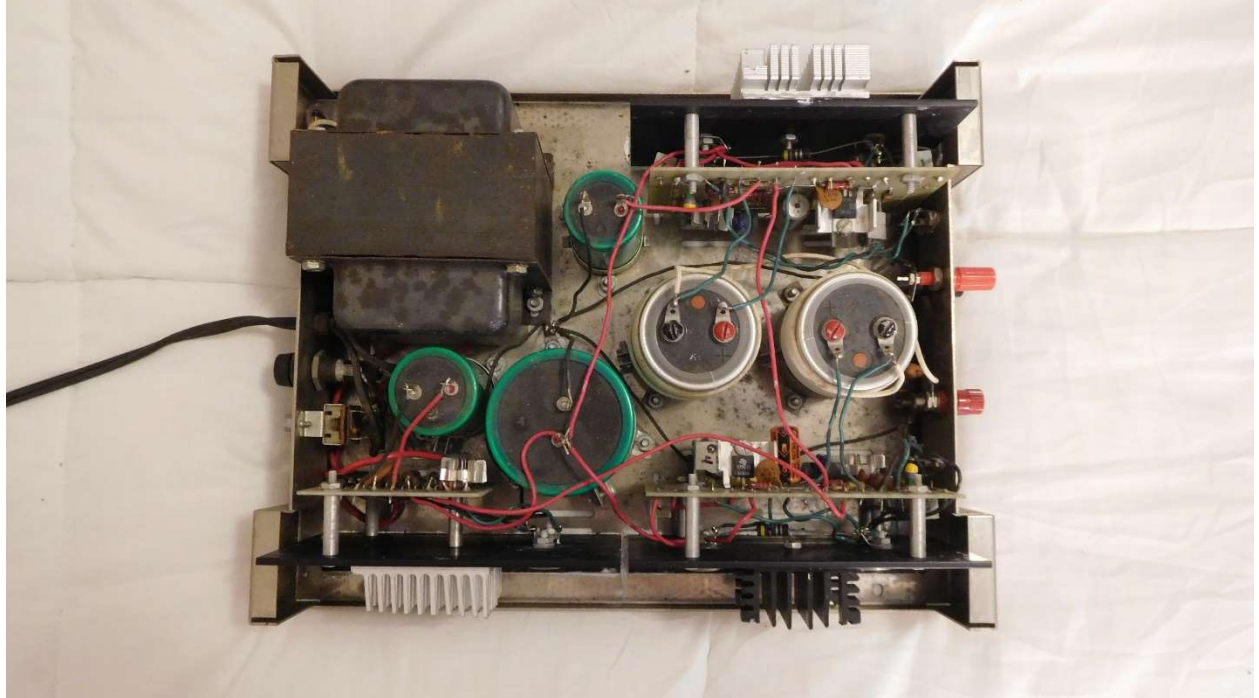
Bottom only has two screws.

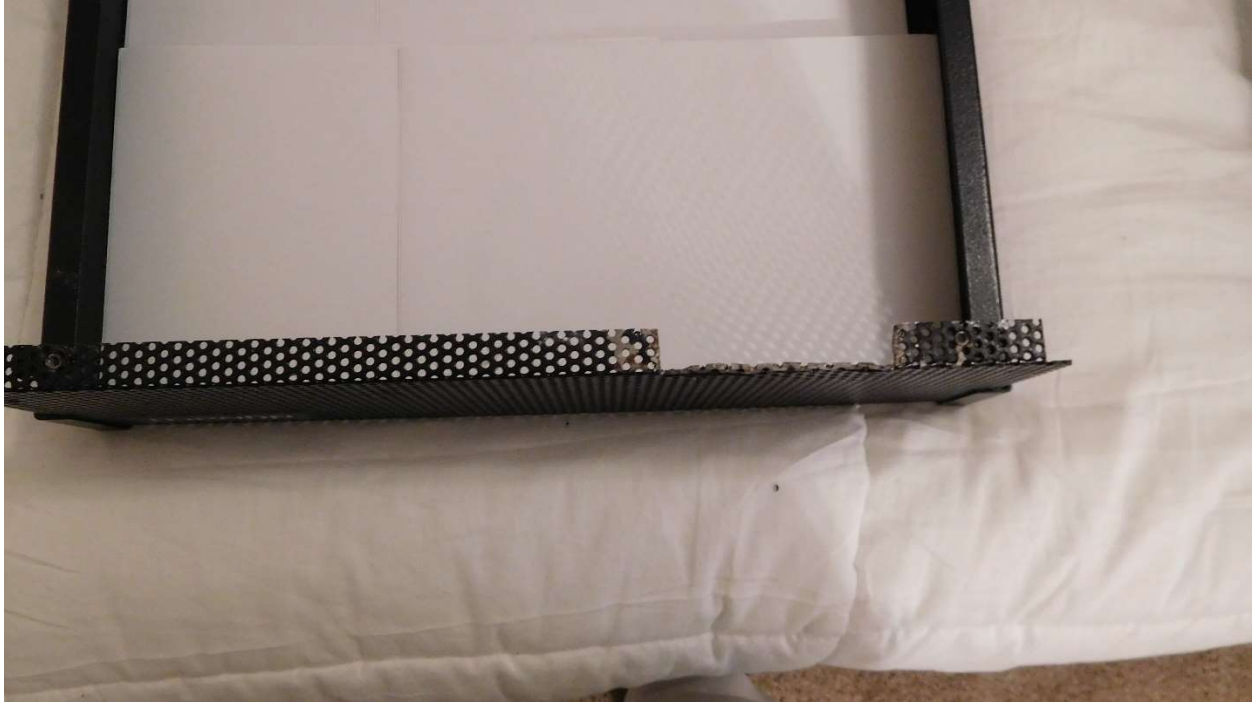
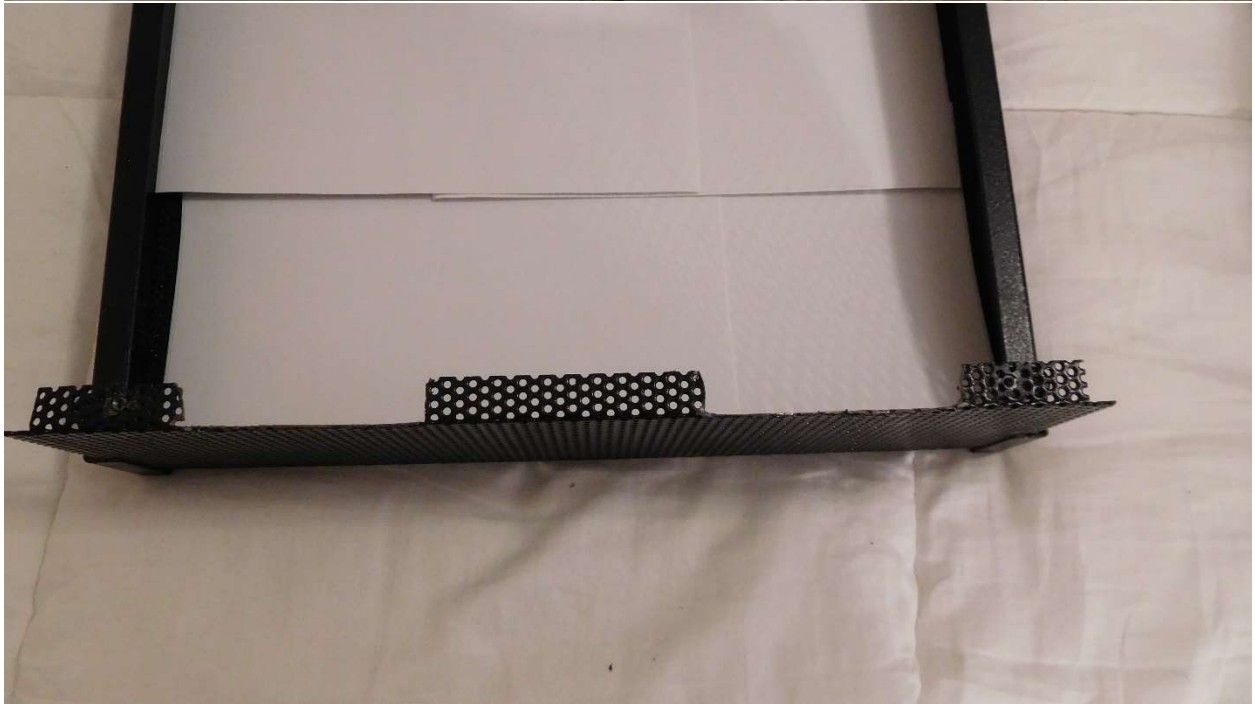
I put white paper in the bottom of the cover. This clearly shows where this cover has been chopped to allow the auxiliary heatsinks to pass.
